Swimming pool pipe rehabilitation

Technology Brush coating

Client Major leisure park

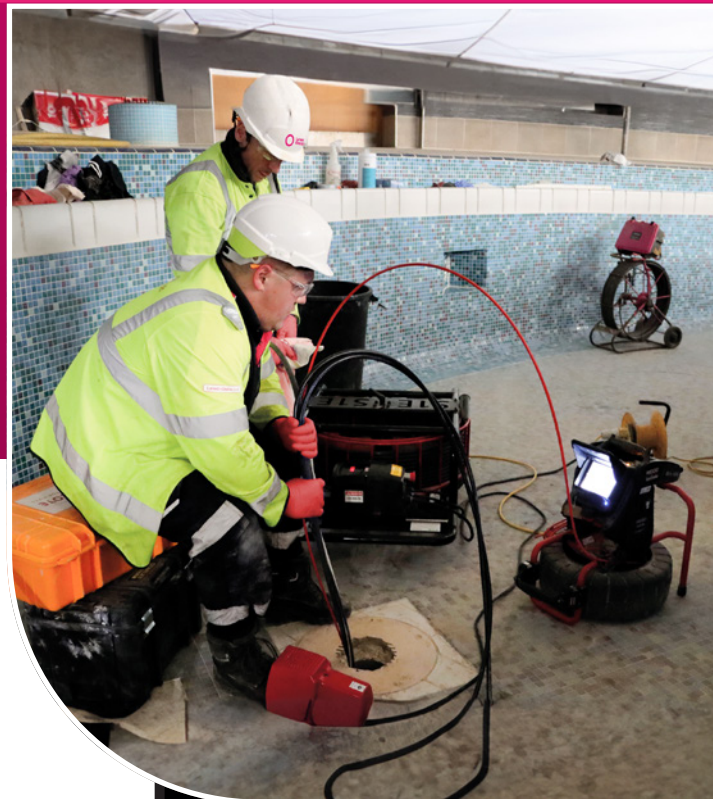
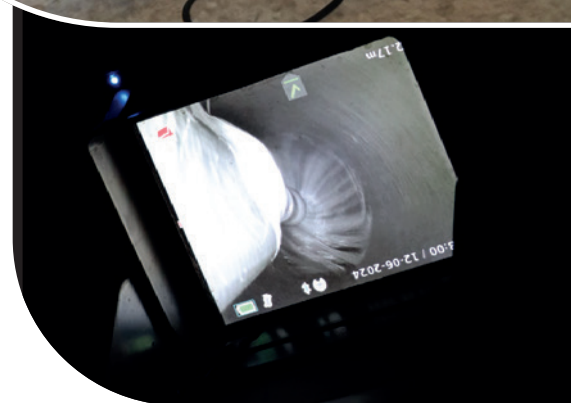
A CCTV pipe survey, of six sets of four pipes between 2-4 metre long of DN100 was carried out with a maximum of five bends. This confirmed corrosion and cracks were causing water leaks and chlorine build-up along the swimming pools pipe network.

Working collaboratively with Picote Solutions, the decision was made to use the new state-of-the-art Xpress Brush Coating system from Picote Solutions. This innovative technology was chosen for its effectiveness in providing a durable, long-lasting solution to pipe corrosion and leakage.

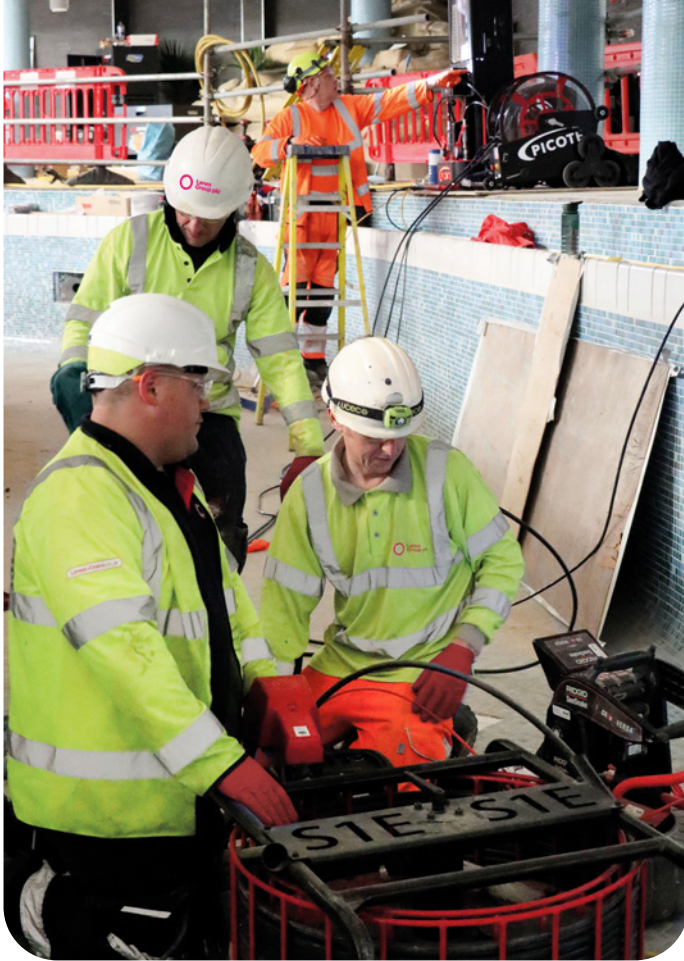
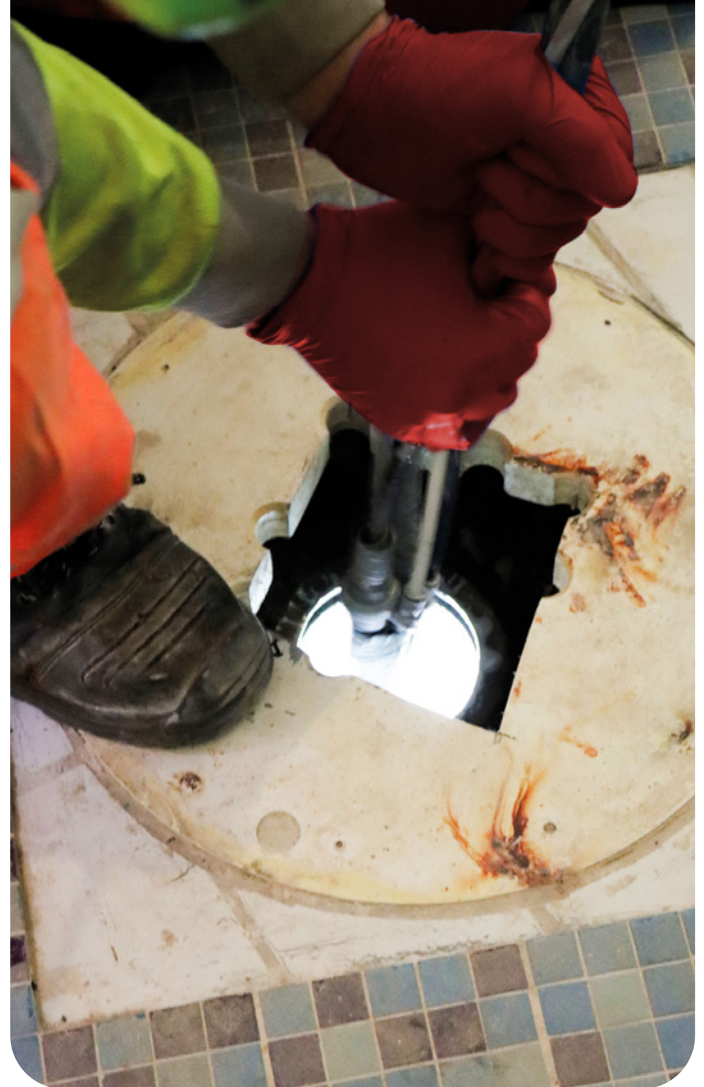
Before

The rehabilitation of the swimming pool pipes was completed successfully and on schedule to the operations project timescales, much to the satisfaction of the client. The newly coated pipes now offer enhanced durability and reliability, ensuring that guests can enjoy the swimming pool without interruptions.
